**Blessed Assurance Home Inspections**

## Property Inspection Report

Property address: **sample street**

Inspection date: **11/19/2011**

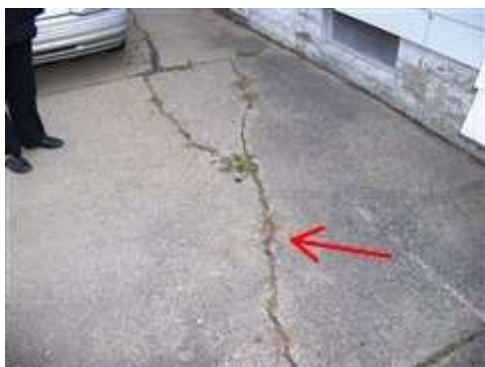
**Photo 6**

The driveway has significant cracks and/or deterioration in one or more areas. A qualified contractor should evaluate and repair or replace driveway sections as necessary.

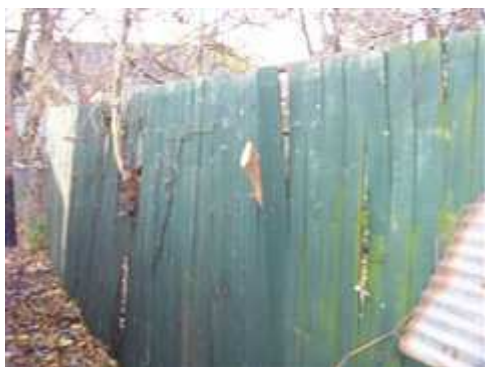
**Photo 15**

Fences and/or gates are damaged and/or deteriorated in some areas. A qualified contractor should evaluate and make repairs or replace sections as necessary.

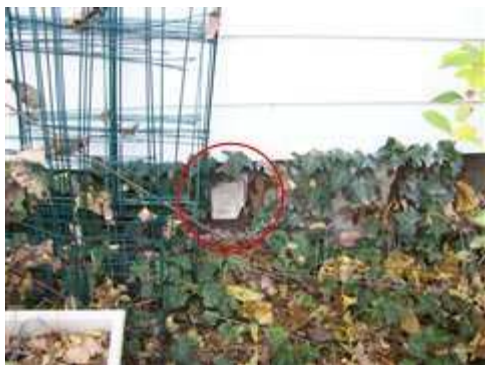
**Photo 11**

One or more exhaust duct end caps are damaged and/or deteriorated. Their purpose is to prevent unconditioned air from entering the house, and keep out birds, rodents and bugs. Blocked ducts can cause fan motors and/or clothes dryers to overheat and may pose a fire hazard. New vent cap(s) should be installed where necessary.

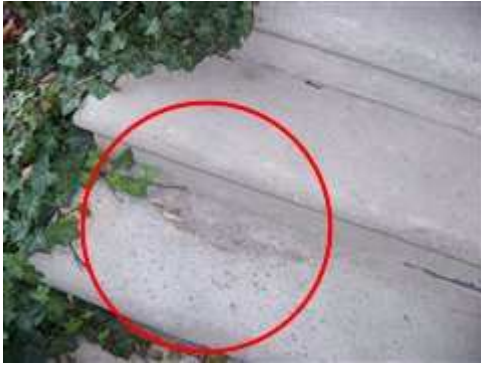
**Photo 3**

Cement stairs on front of house is deteriorated and need to be repaired with a repair type cement

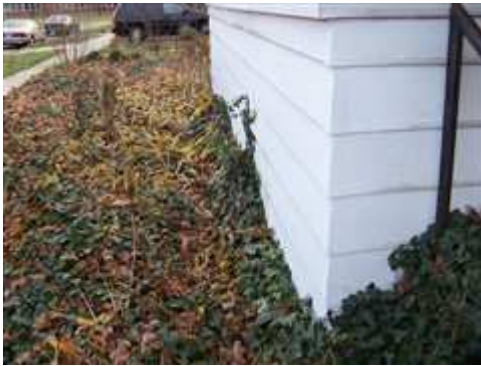
**Photo 2**

Vegetation such as trees, shrubs and/or vines are in contact with or less than one foot from the structure's exterior. Vegetation can serve as a conduit for wood destroying insects and may retain moisture against the exterior after it rains. Vegetation should be pruned and/or removed as necessary to maintain a one foot clearance between it and the structure's exterior.

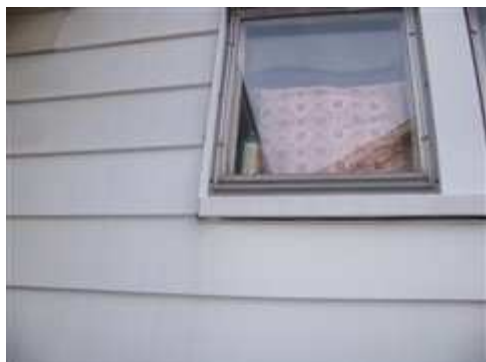
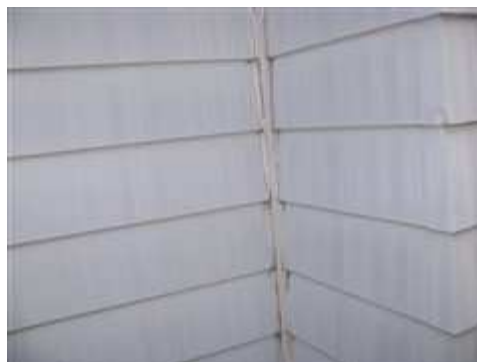
Caulk is missing or deteriorated in some areas and should be replaced and/or applied where necessary. For more information on caulking, visit:  
[The Ins and Outs of Caulking.](#)

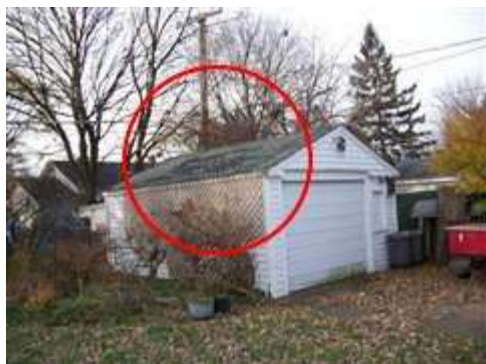
Photo 13

The roof surface material is beyond or at the end of its service life and needs replacing now. The client(s) should consult with a qualified roofing contractor to determine replacement options and costs. This is the garage roof.

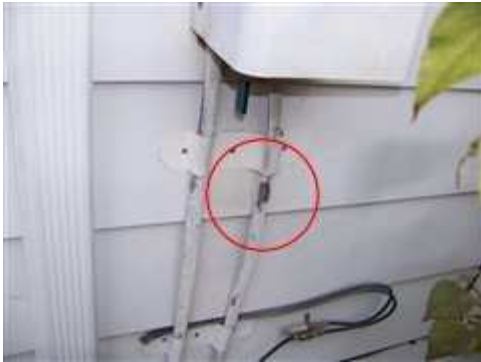
Photo 9

The service entrance wire insulation is frayed and/or deteriorated in one or more areas. A qualified electrician should evaluate and make repairs or replace wires as necessary.

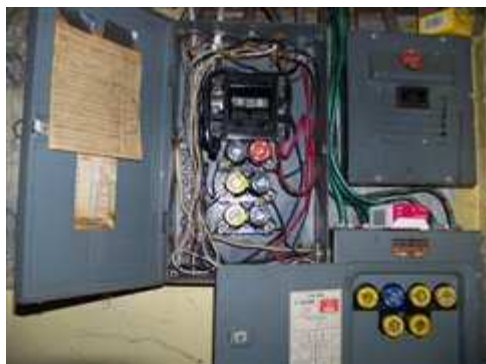
**Photo 29**

The electric service to this property appears to be rated at substantially less than 200 amps, and may be inadequate for the client(s) needs. Recommend consulting with a qualified electrician about upgrading to a 200 amp service.

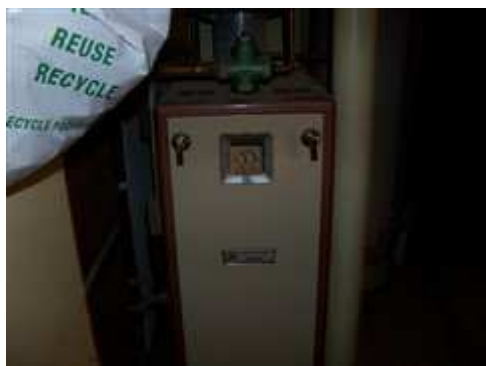
**Photo 26**

Boiler appears to be at least 50 years old. While it is functional homeowner should budget to replace because it is beyond its life expectancy.

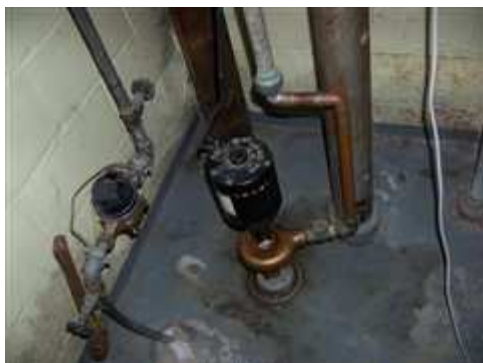
Photo 19

A sump pump is installed on the premises. This may indicate that water accumulates inside or below the structure. Recommend asking the property owners how often the sump pump operates and for how long at different times of the year. Also, the clients should be aware that the service life of most sump pumps is between five and seven years, and that the pump may need replacing soon depending on its age and how much it operates. This sump pump appears to be at least 30 years old

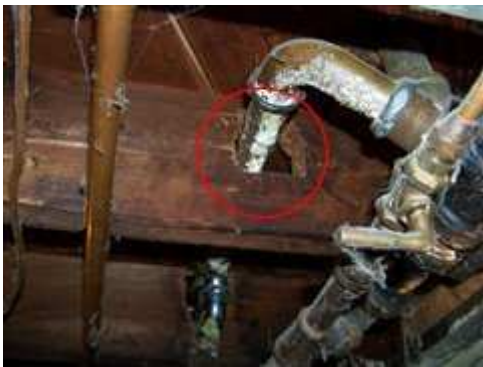
**Photo 30**

One or more joists are damaged due to non-standard or substandard notching and/or hole boring. Standard building practices specify the following limitations for notching and boring joists:

- Notches should not be cut in the middle third of any joist
- Notches should not be deeper than 1/6 of the joist depth
- Notches should not be deeper than 1/4 of the joist depth at joist ends
- Bored holes should not be closer than 2 inches to the edges of the joist
- Bored holes should not be wider than 1/3 of the joist depth

A qualified contractor should evaluate and repair as necessary.

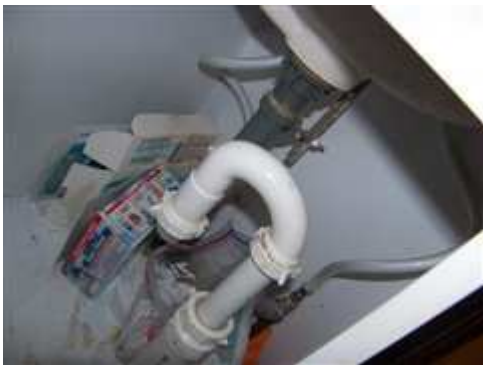
**Photo 34**

**44)** ⚡🔧🔍 One or more sink drains use an s-trap rather than a vented p-trap. Water seals (the water lying in the bottom of the u-shaped pipe) may be lost when discharges occur in the system, resulting in sewer gases entering the structure. Recommend having a qualified plumber evaluate and replace s-traps with vented p-traps where necessary.

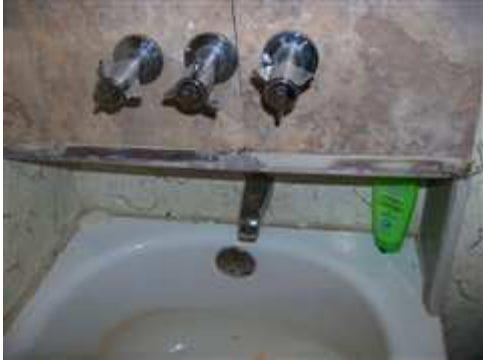
**Photo 36**

**48)** panel in shower area is not water resistant, recommend replacing with something more suitable

for a shower(tile ,fiberglass surround,etc)

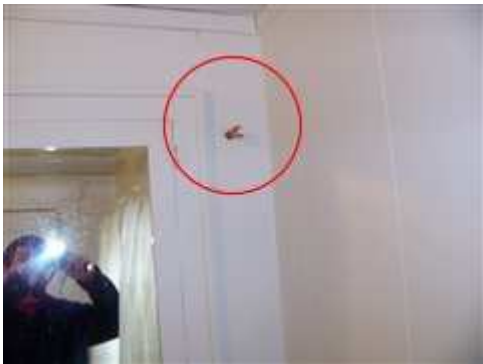
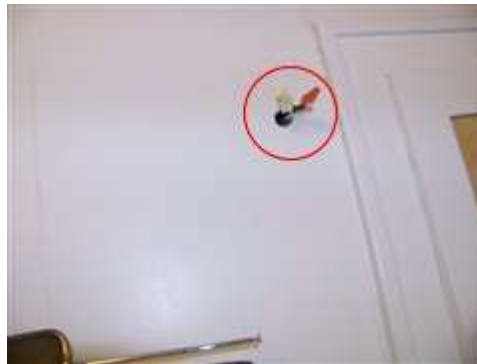
**49)** It appears the light fixtures in the upstairs bath have been removed .The exposed wires need to be in a box with a cover

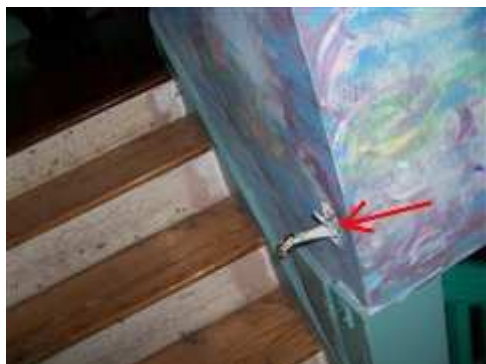
**Photo 45**

One or more flights of stairs with more than two risers have no handrail installed. This is a safety hazard. A qualified contractor should install graspable handrails that your hand can completely encircle at stairs where missing, and as per standard building practices.

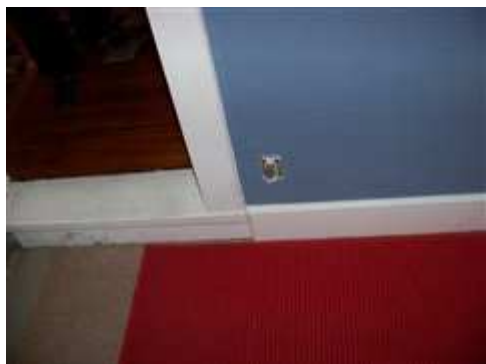
**Photo 41**

Cover plate(s) are missing from one or more electric boxes, such as for receptacles, switches and/or junction boxes. They are intended to contain fire and prevent electric shock from exposed wires. This is a safety hazard due to the risk of fire and shock. Cover plates should be installed where missing.

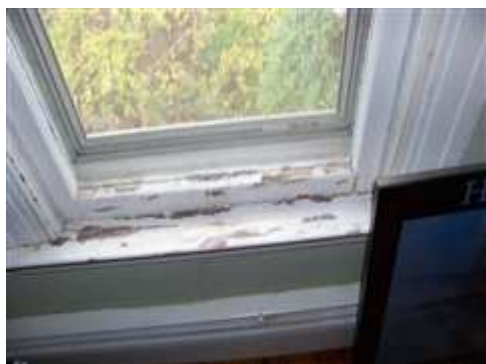
**Photo 43**

The sash spring mechanism(s) in one or more windows are broken or loose. A qualified contractor or service technician should evaluate and make repairs as necessary so the window(s) operate as intended (open easily, stay open without support, close easily, etc.).

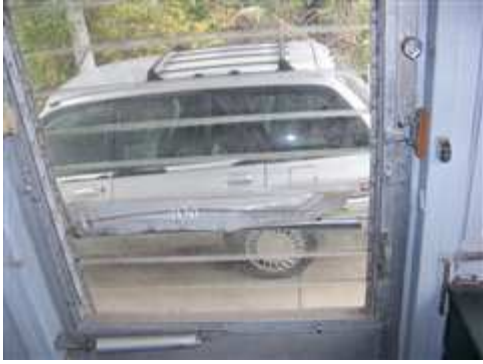
**Photo 46**

Glass in one or more windows is broken. A qualified contractor should replace glass where

necessary.

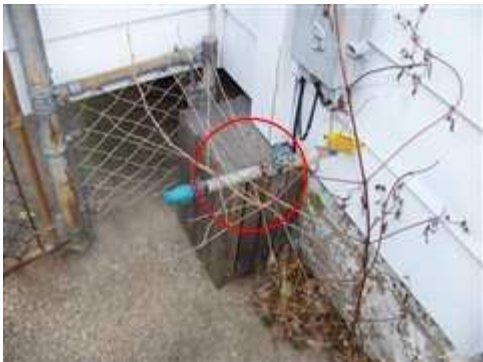
**Photo 7**

The hose bib is not frost proof and could freeze and rupture in cold weather. All hose connections need anti siphon valves

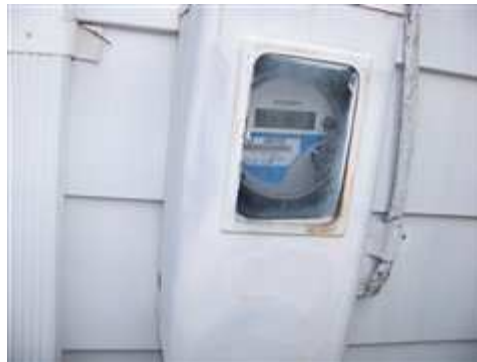
**Photo 8**

This Is 60 amp meter block. Meter is a 200 amp. Meter block needs to be replaced so it will match meter

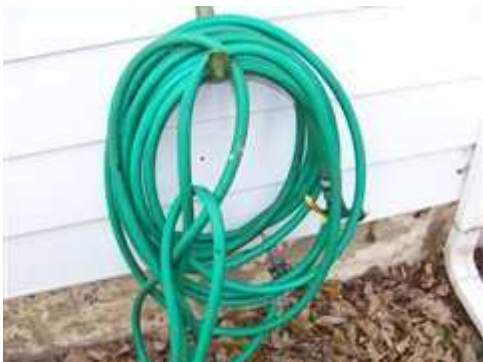
**Photo 10**

The hose bib is not frost proof and could freeze and rupture in cold weather. All hose connections need anti siphon valves

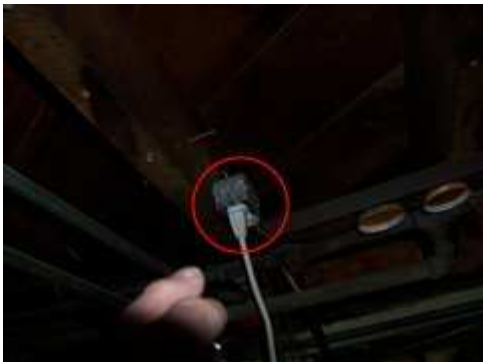
**Photo 20**

Cover is missing on this outlet in the basement. Cover needs to be installed to prevent shock

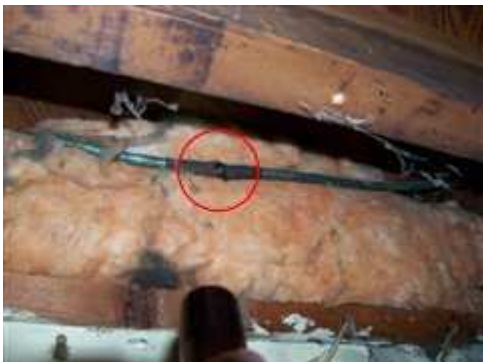
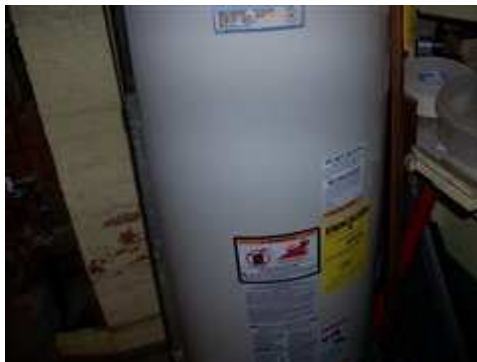
This wire is spliced together and

taped, should be in a junction box with a cover

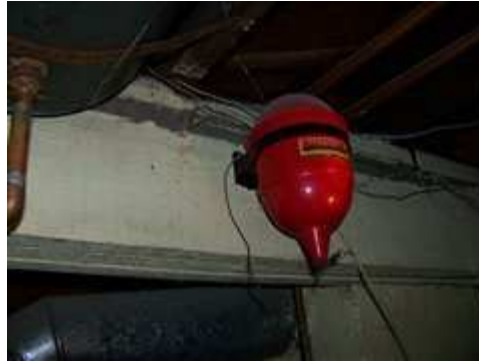
**Photo 25**

This is a chemical fire suppressant device. I recommend removal because the chemical inside is very toxic

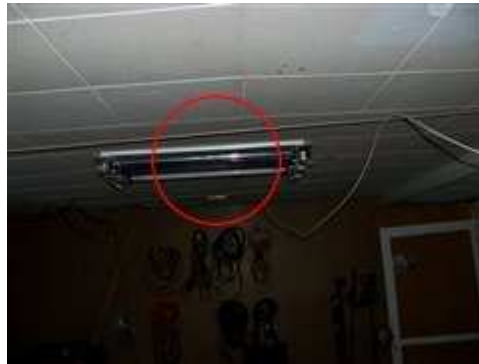
**Photo 28**

Exposed wire because of missing cover, I recommend replacement

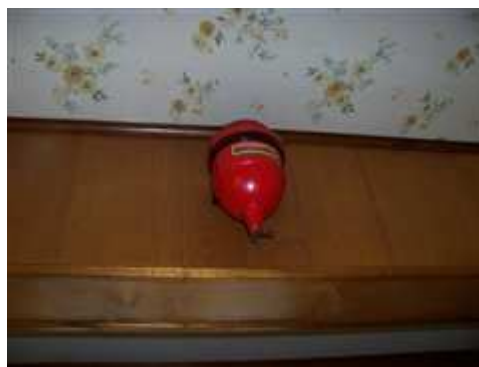
**Photo 32**

This is a chemical fire suppressant device. I recommend removal because the chemical inside is very toxic

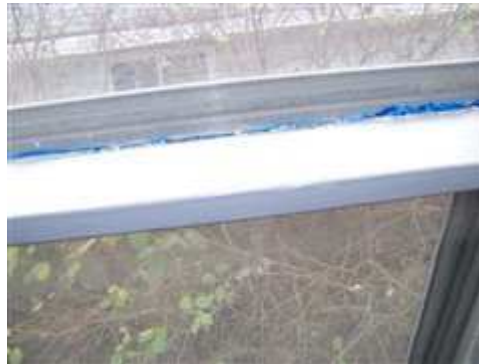
**Photo 40**  
the lock is missing on this window

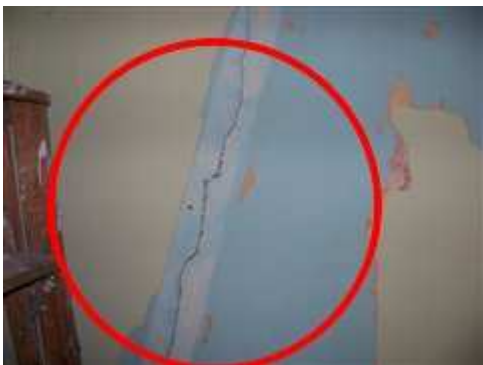
**Photo 42**  
the plaster in th front upstairs bedroom has cracks and will need to be replaced.It appears to be superficial and not structural

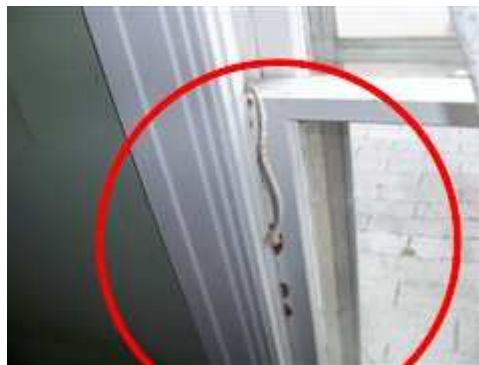
**Photo 44**  
the rope s holding the counter weights has been cut.Window will not stay open without this being repaired
